FY2019 Summary Report & FY2020 Coordinated Monitoring

**CANADIAN AND RED RIVER
BASINS ADVISORY COMMITTEE MEETING**

APRIL 9, 2019 – AMARILLO, TEXAS

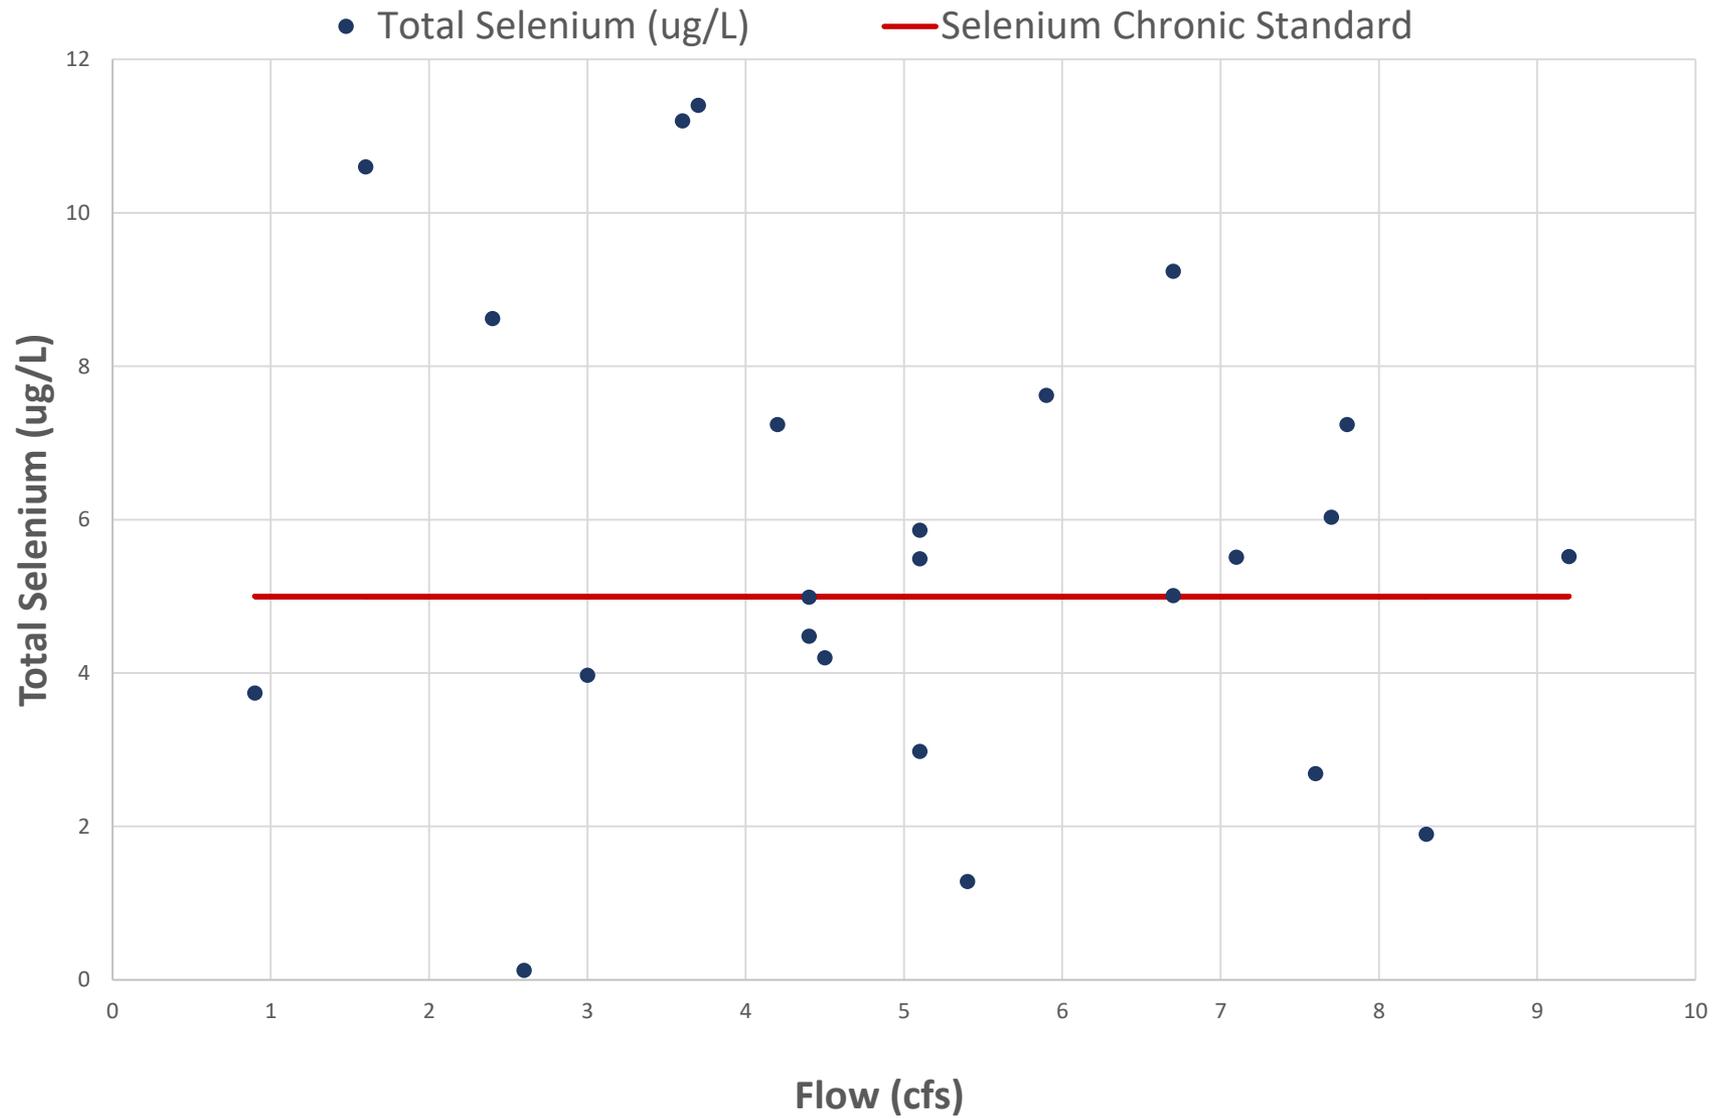
AU 0101A_01 Selenium versus Flow

- Canadian River Below Lake Meredith (0101)
- Dixon Creek (0101A)
 - Bacteria, depressed DO, and selenium impairments
 - Chlorophyll-*a* and nitrate concerns
 - RUAA has been completed and submitted to TCEQ
- Rock Creek (0101B)
- White Deer Creek (0101C)

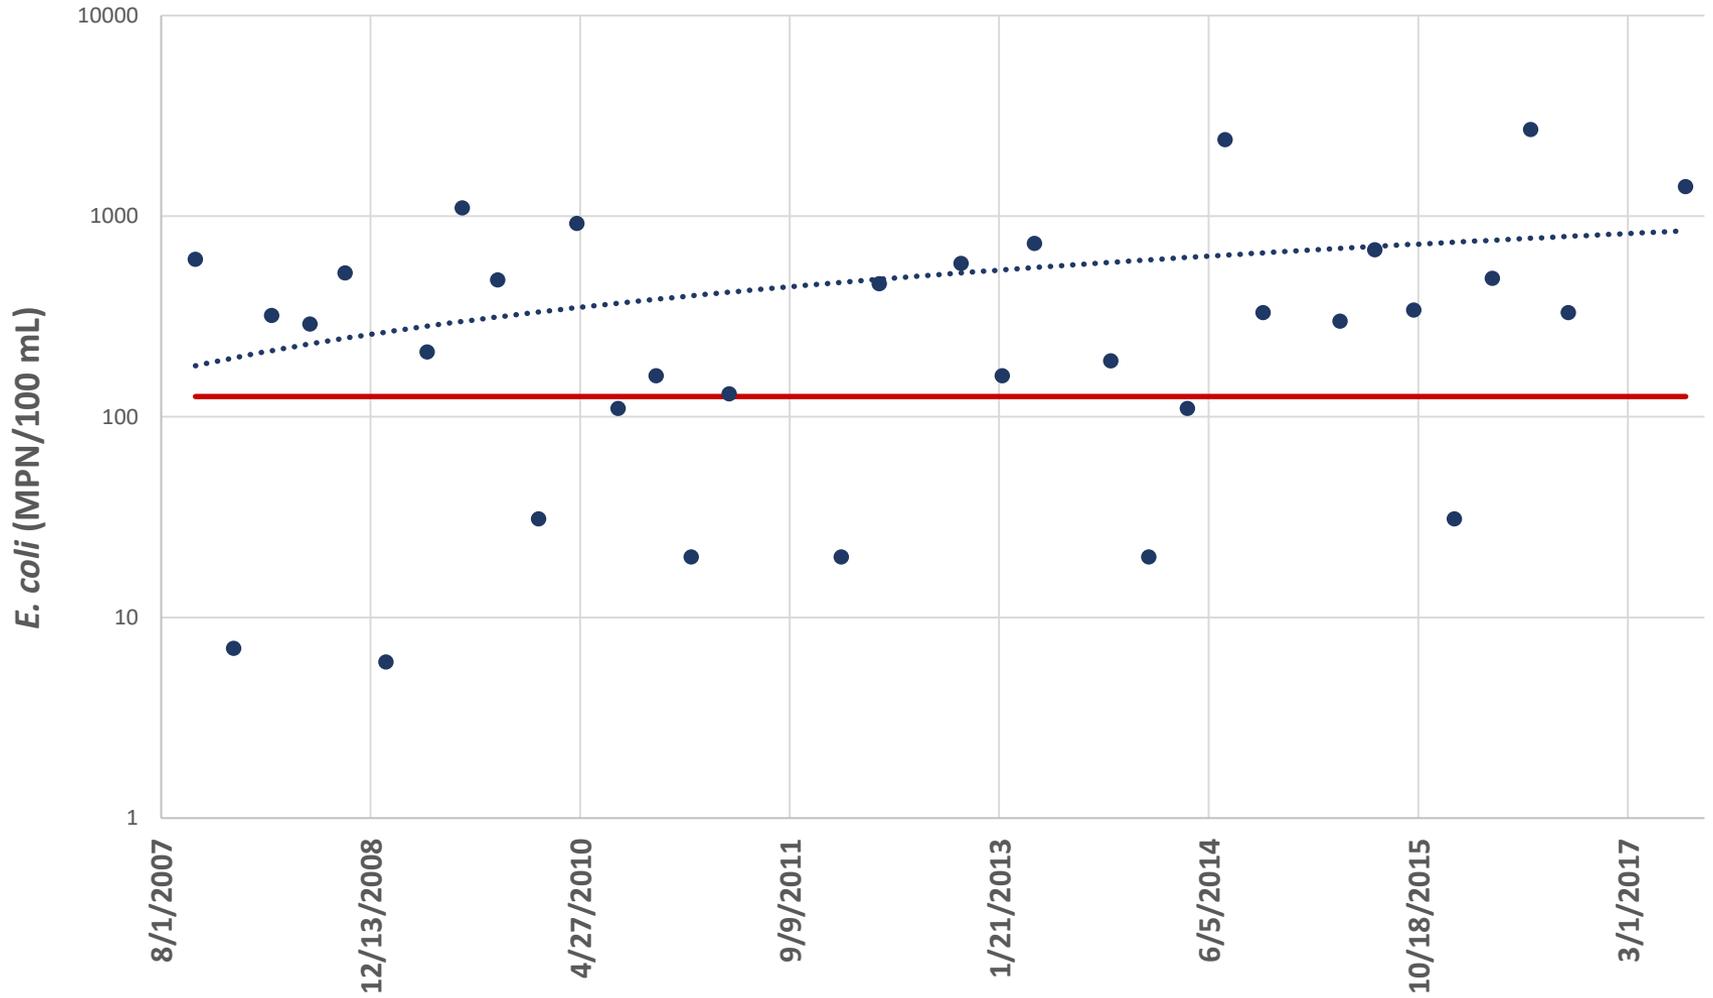
AU 0101B_01 *E. coli*

- Canadian River Below Lake Meredith (0101)
- Dixon Creek (0101A)
- Rock Creek (0101B)
 - No impairments
 - Nitrate, chlorophyll-*a*, total phosphorus, and bacteria concerns
- White Deer Creek (0101C)

● *E. coli* (MPN/100 mL) — *E. coli* Standard

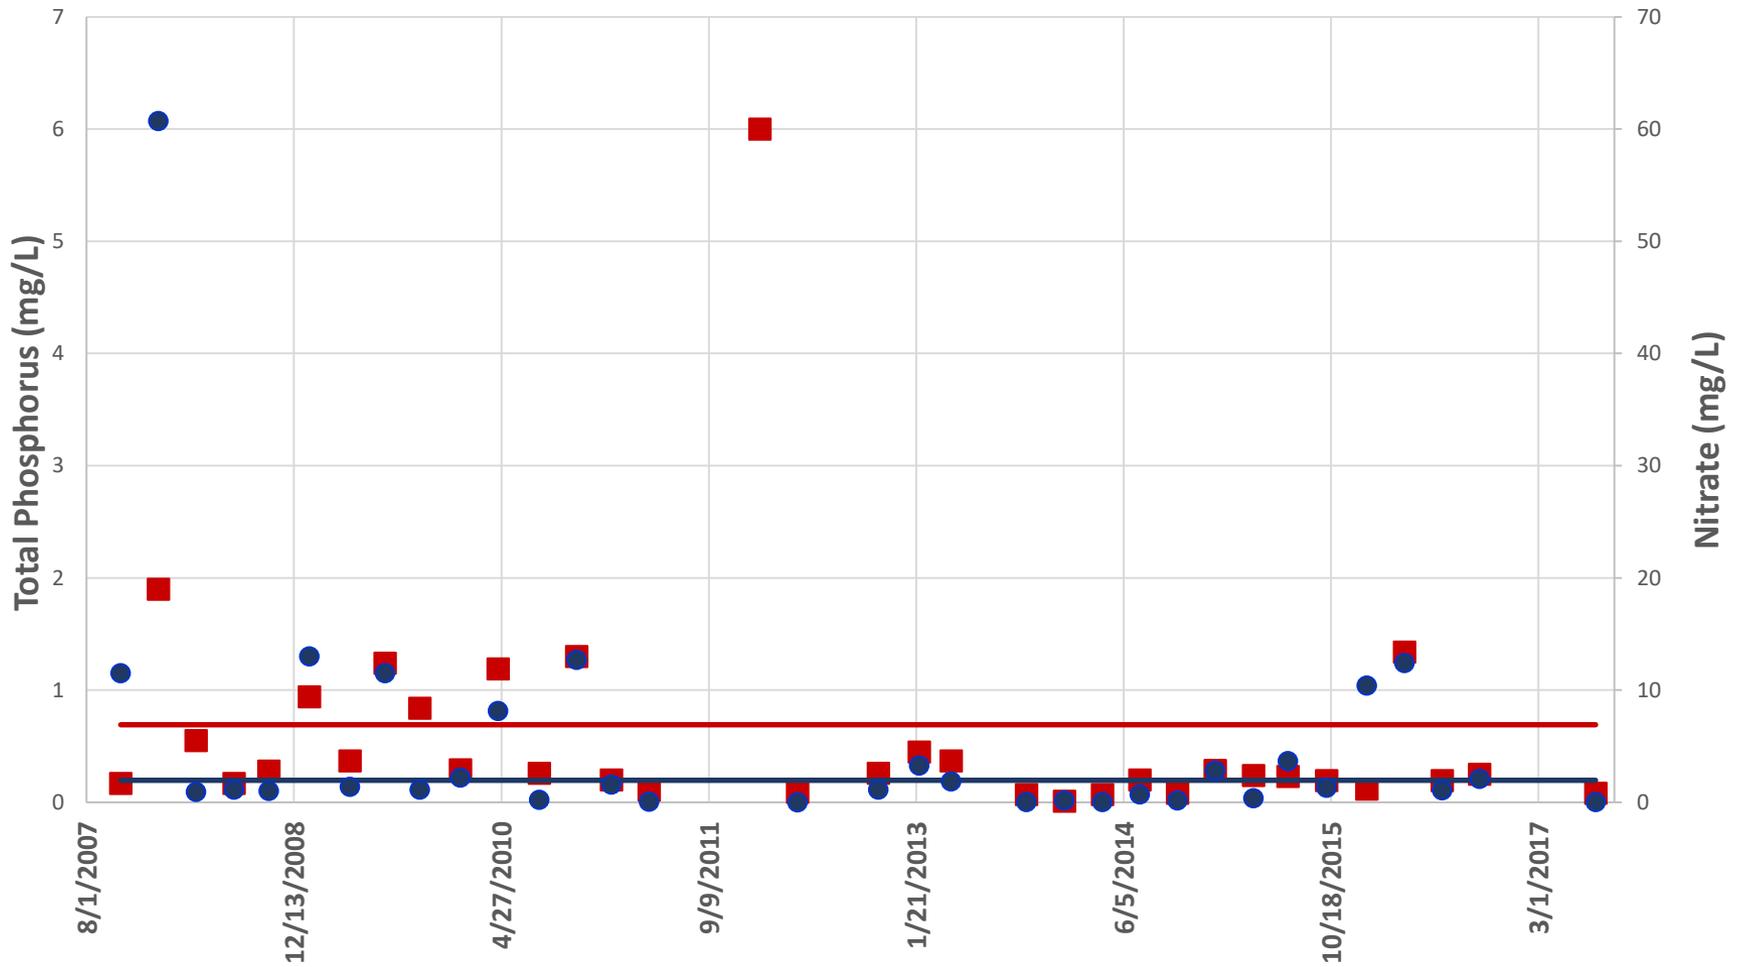
AU 0101B_01 Total Phosphorus and Nitrate

■ Total Phosphorus (mg/L) — Total Phosphorus Screening Level ● Nitrate & Nitrate+Nitrite (mg/L) — Nitrate Screening Level

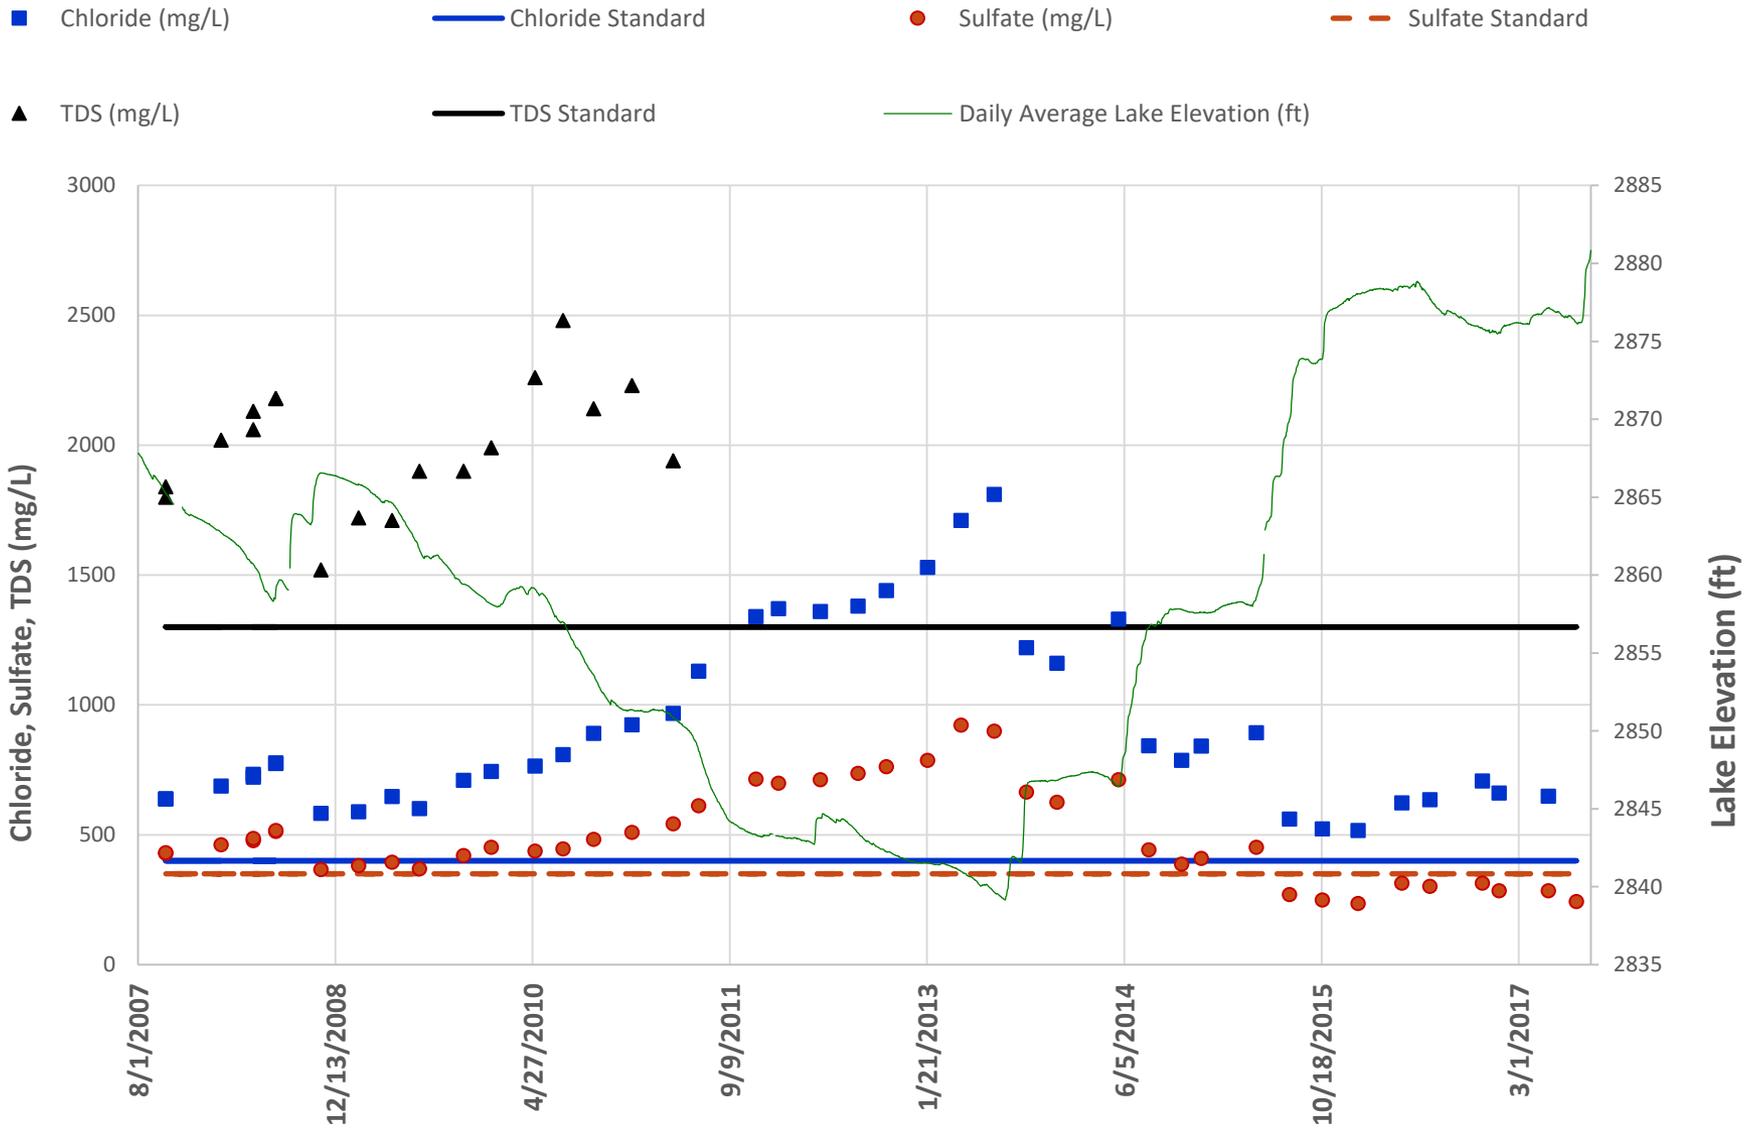
Segment 0102 Chloride, Sulfate, and TDS

- Lake Meredith (0102)
 - Mercury in edible fish tissue, chloride, sulfate, TDS impairments
 - No concerns
- Canadian River Above Lake Meredith (0103)
- Big Blue Creek (0102A)
- East Amarillo Creek (0103A)
- Unnamed Tributary to West Amarillo Creek (0103C)

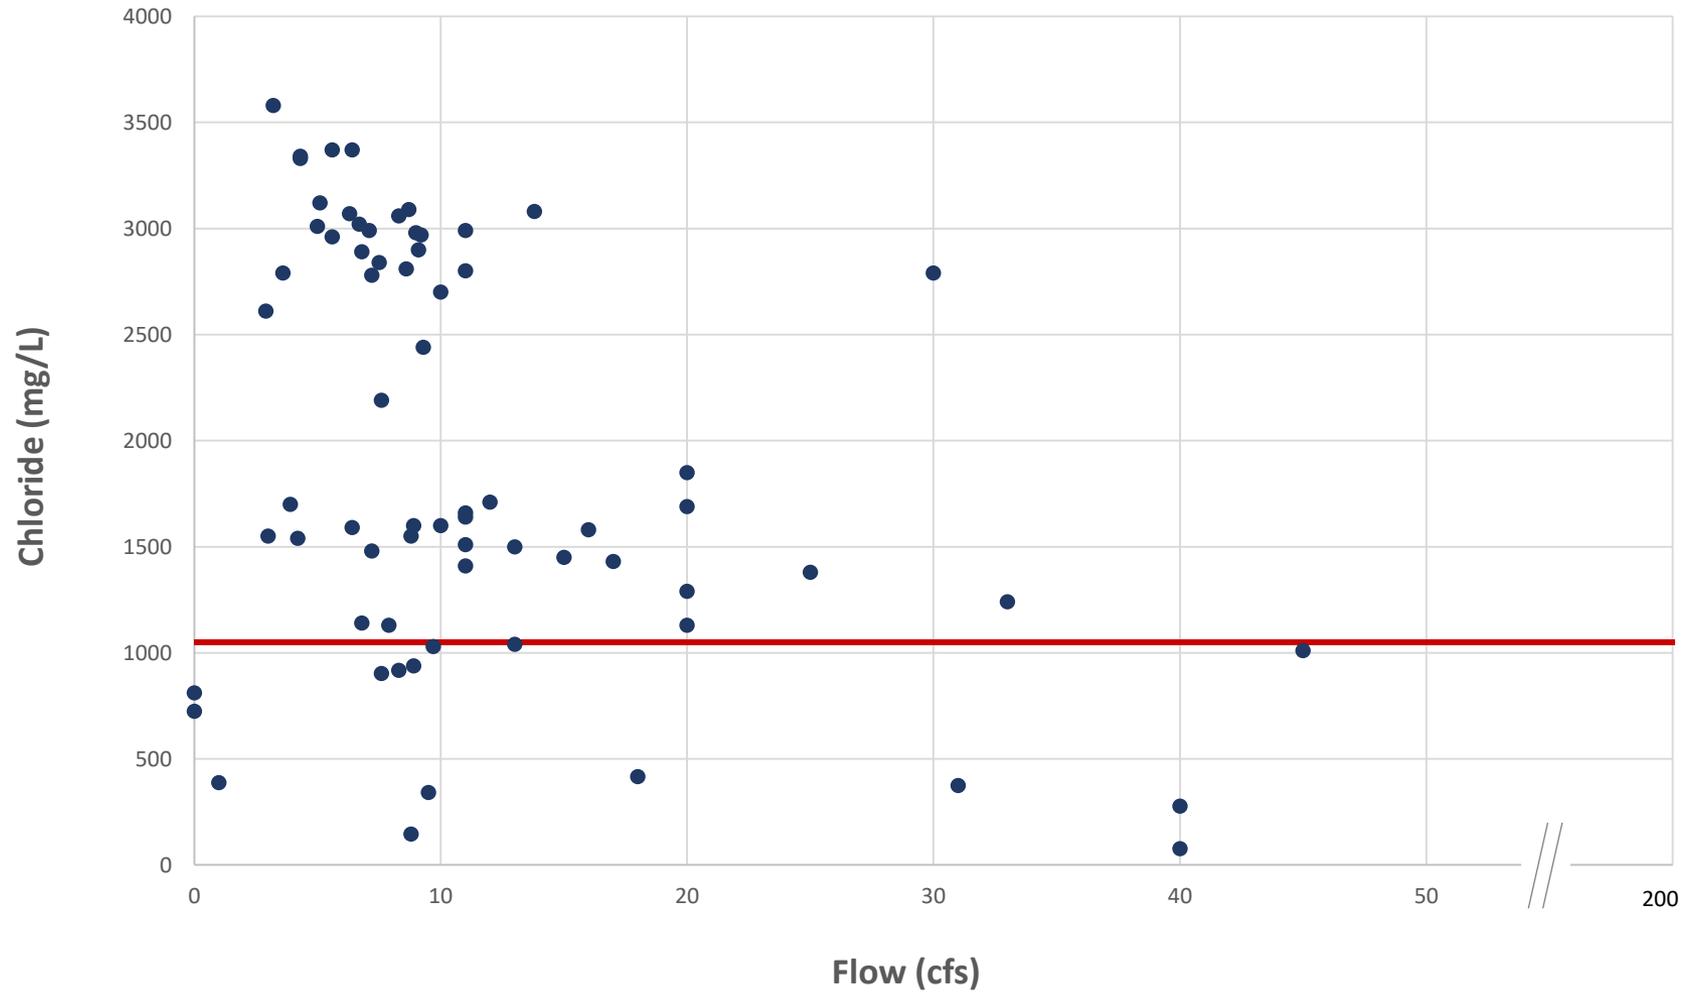
Segment 0103 Chloride versus Flow

- Lake Meredith (0102)
- Big Blue Creek (0102A)
- Canadian River Above Lake Meredith (0103)
 - Chloride impairment
 - No concerns
- East Amarillo Creek (0103A)
- Unnamed Tributary to West Amarillo Creek (0103C)

● Chloride (mg/L) — Chloride Standard

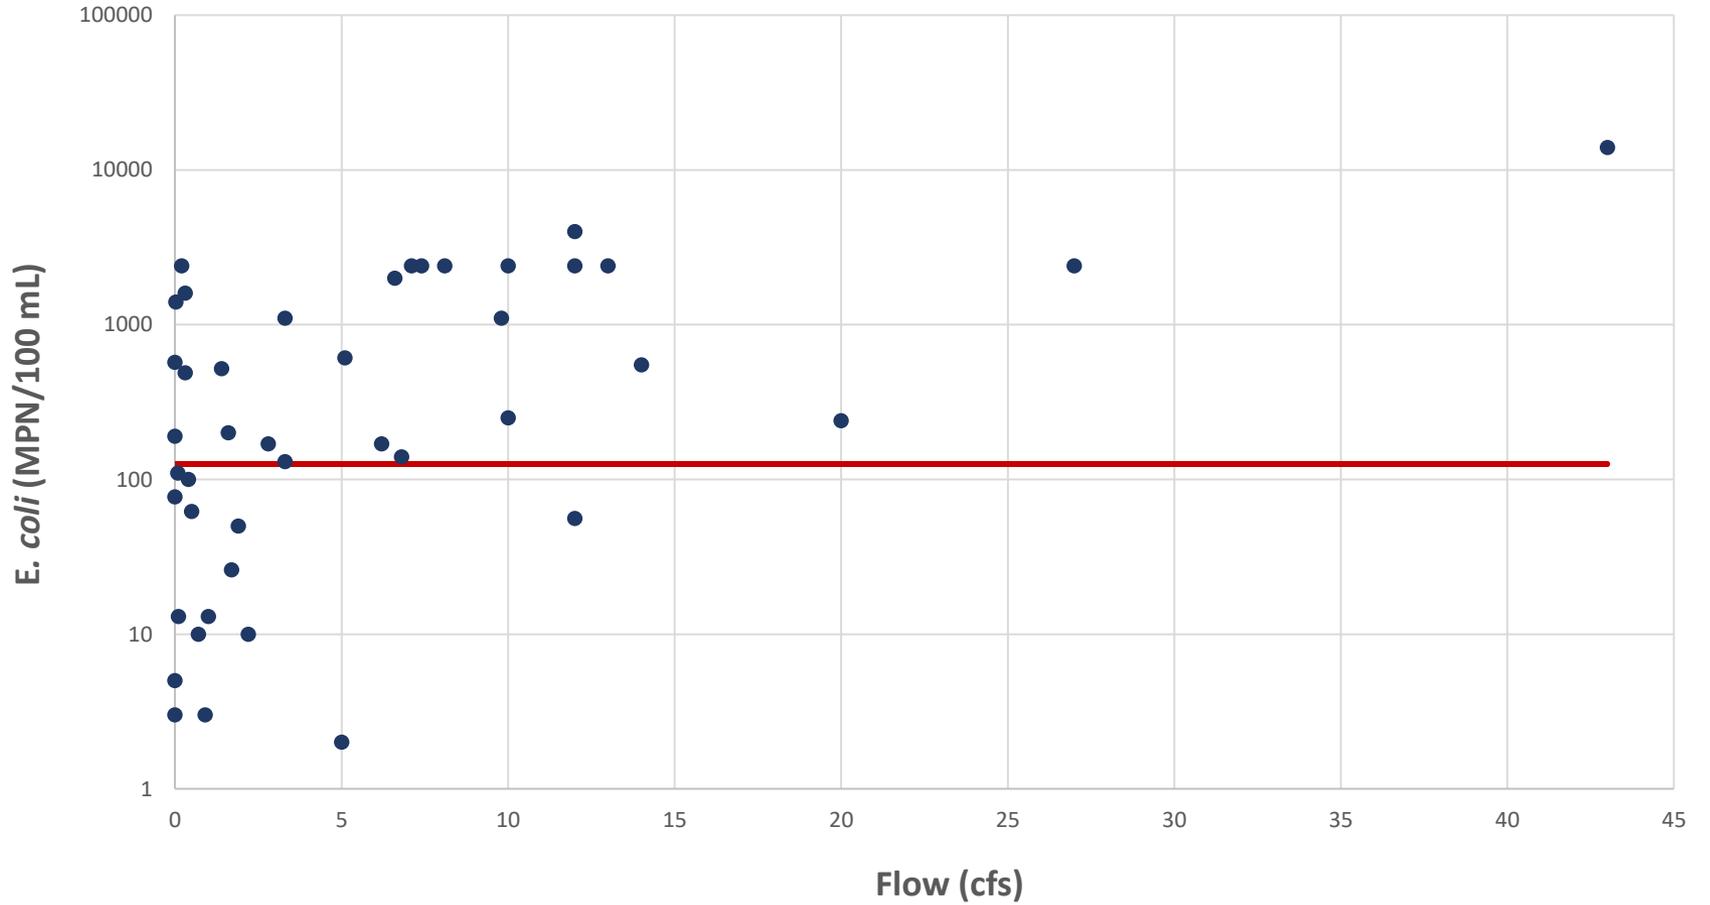
AU 0103A_01 *E. coli* versus Flow

● *E. coli* (MPN/100 mL)

— *E. coli* Standard

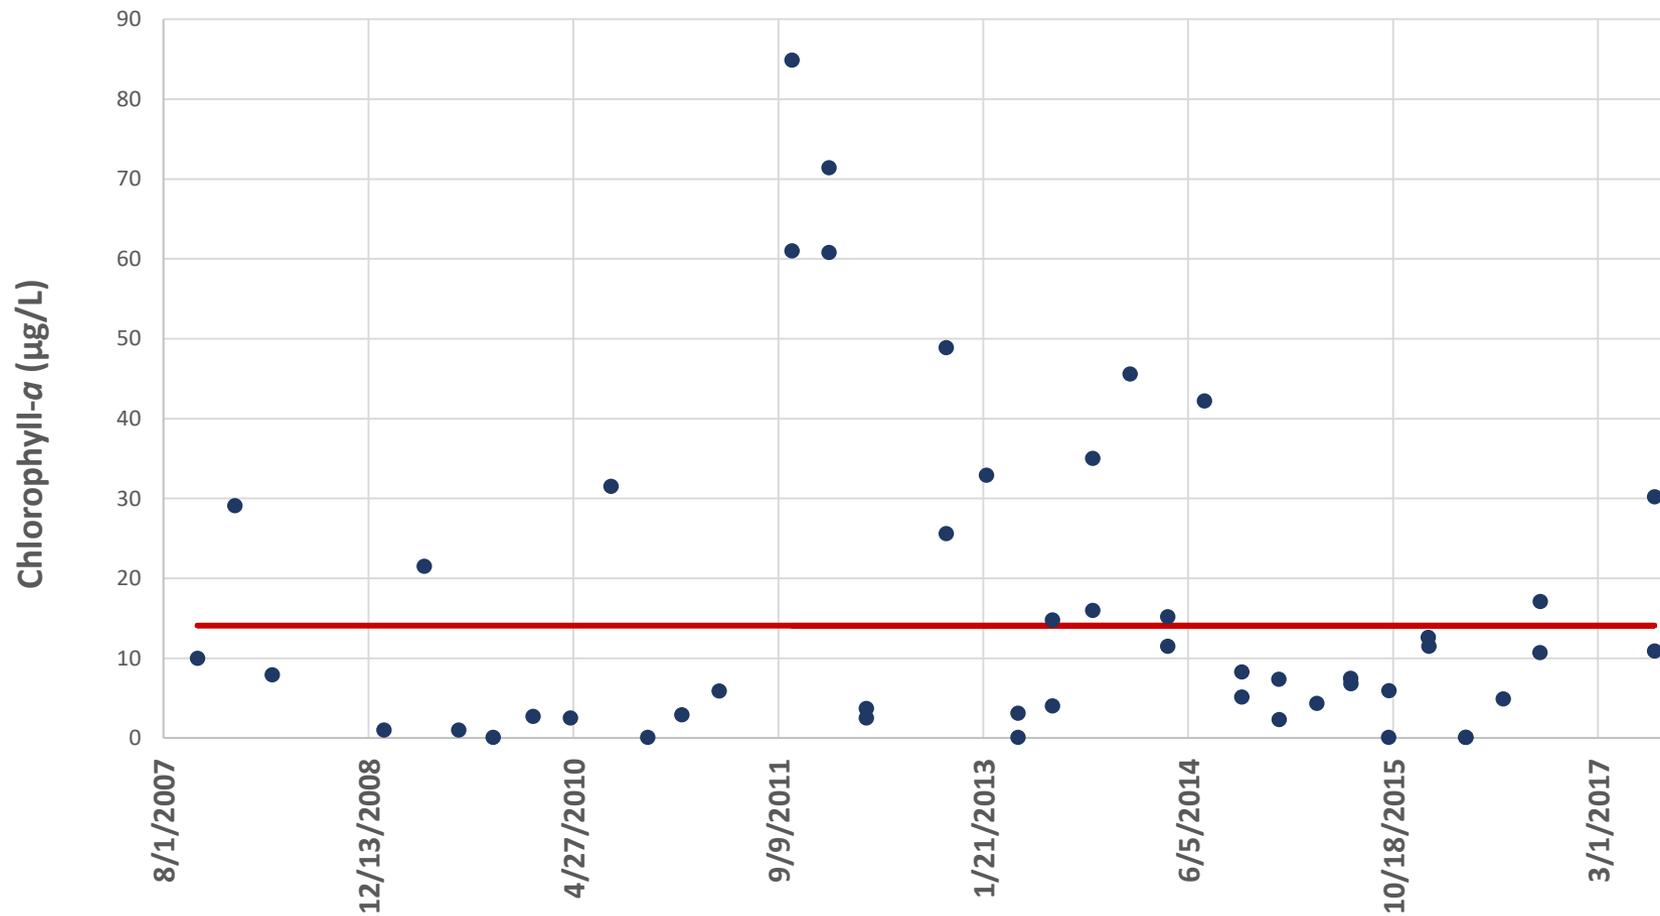
AU 0103A_01 Chlorophyll-*a*

● Chlorophyll-a (ug/L)

— Chlorophyll-A Screening Level

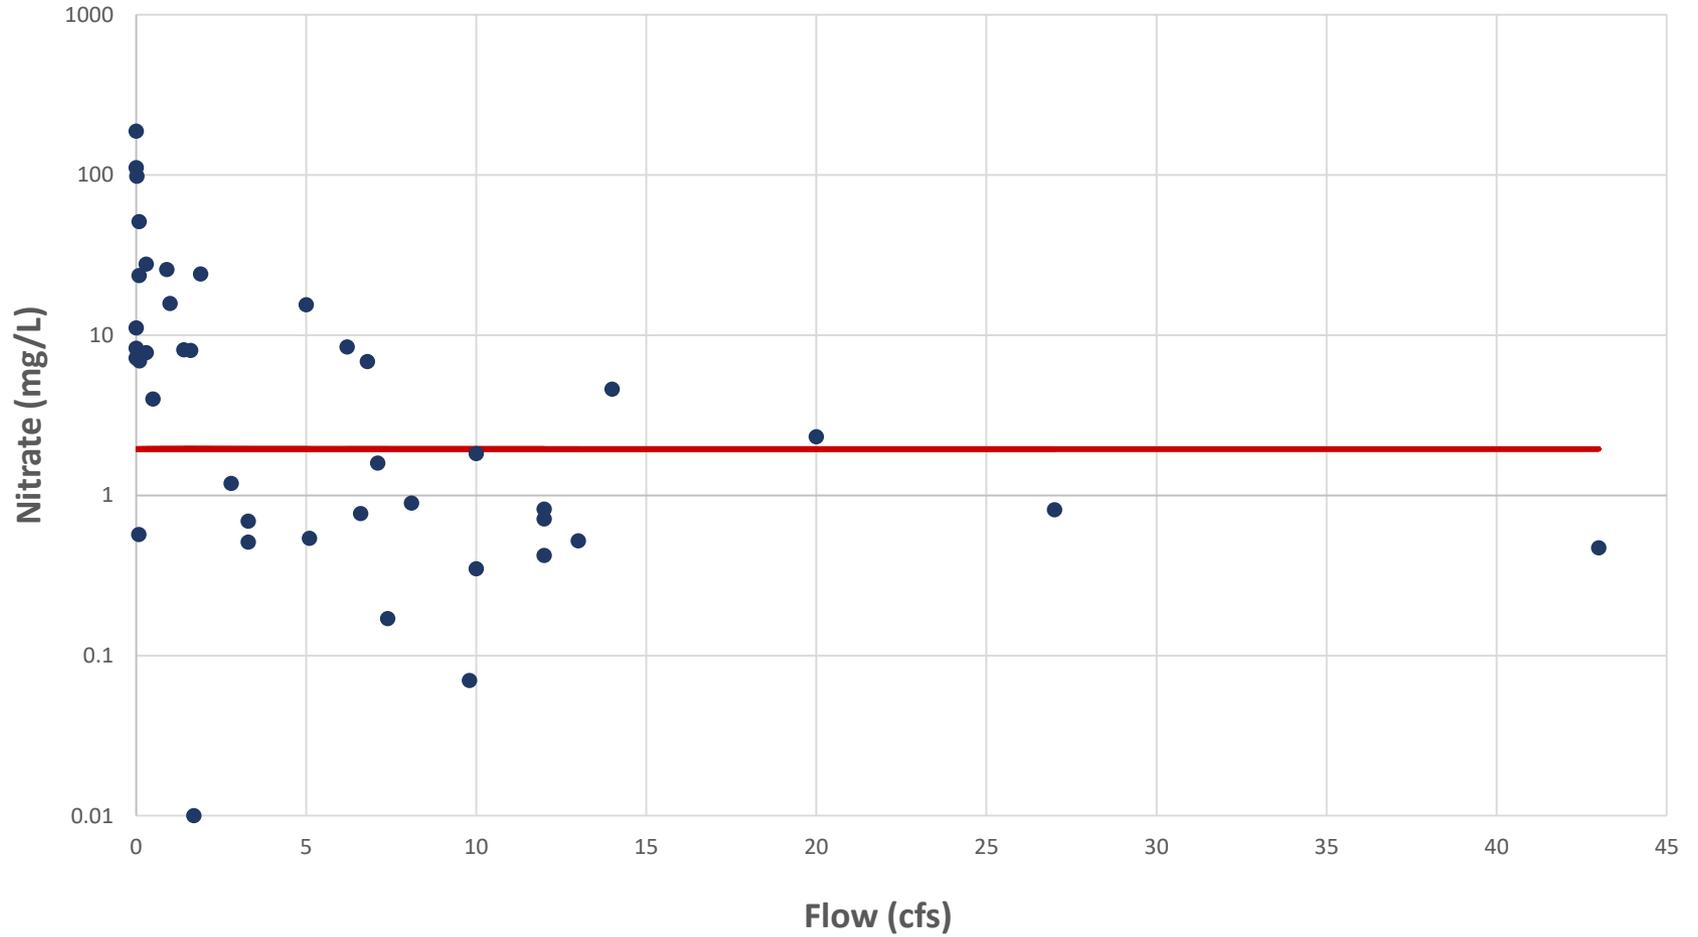
AU 0103A_01 Nitrate versus Flow

● Nitrate & Nitrate+Nitrite (mg/L)

— Nitrate Screening Level

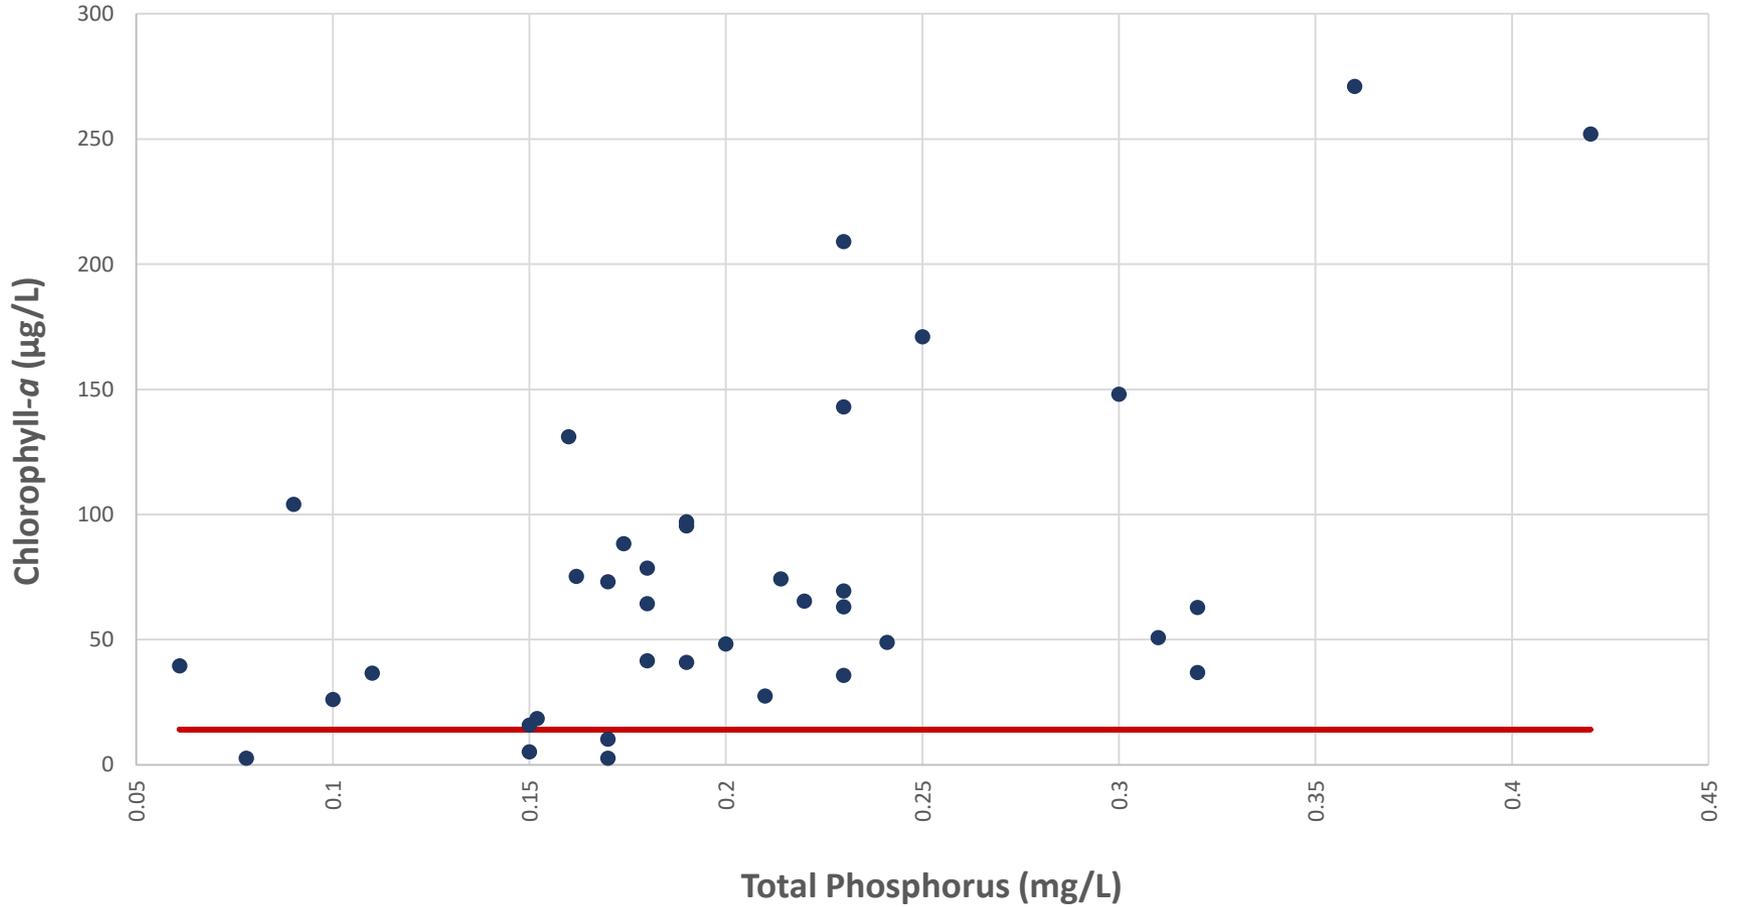
AU 0103A_02 Chlorophyll-*a* versus Total Phosphorus

● Chlorophyll-a (ug/L)

— Chlorophyll-a Screening Level

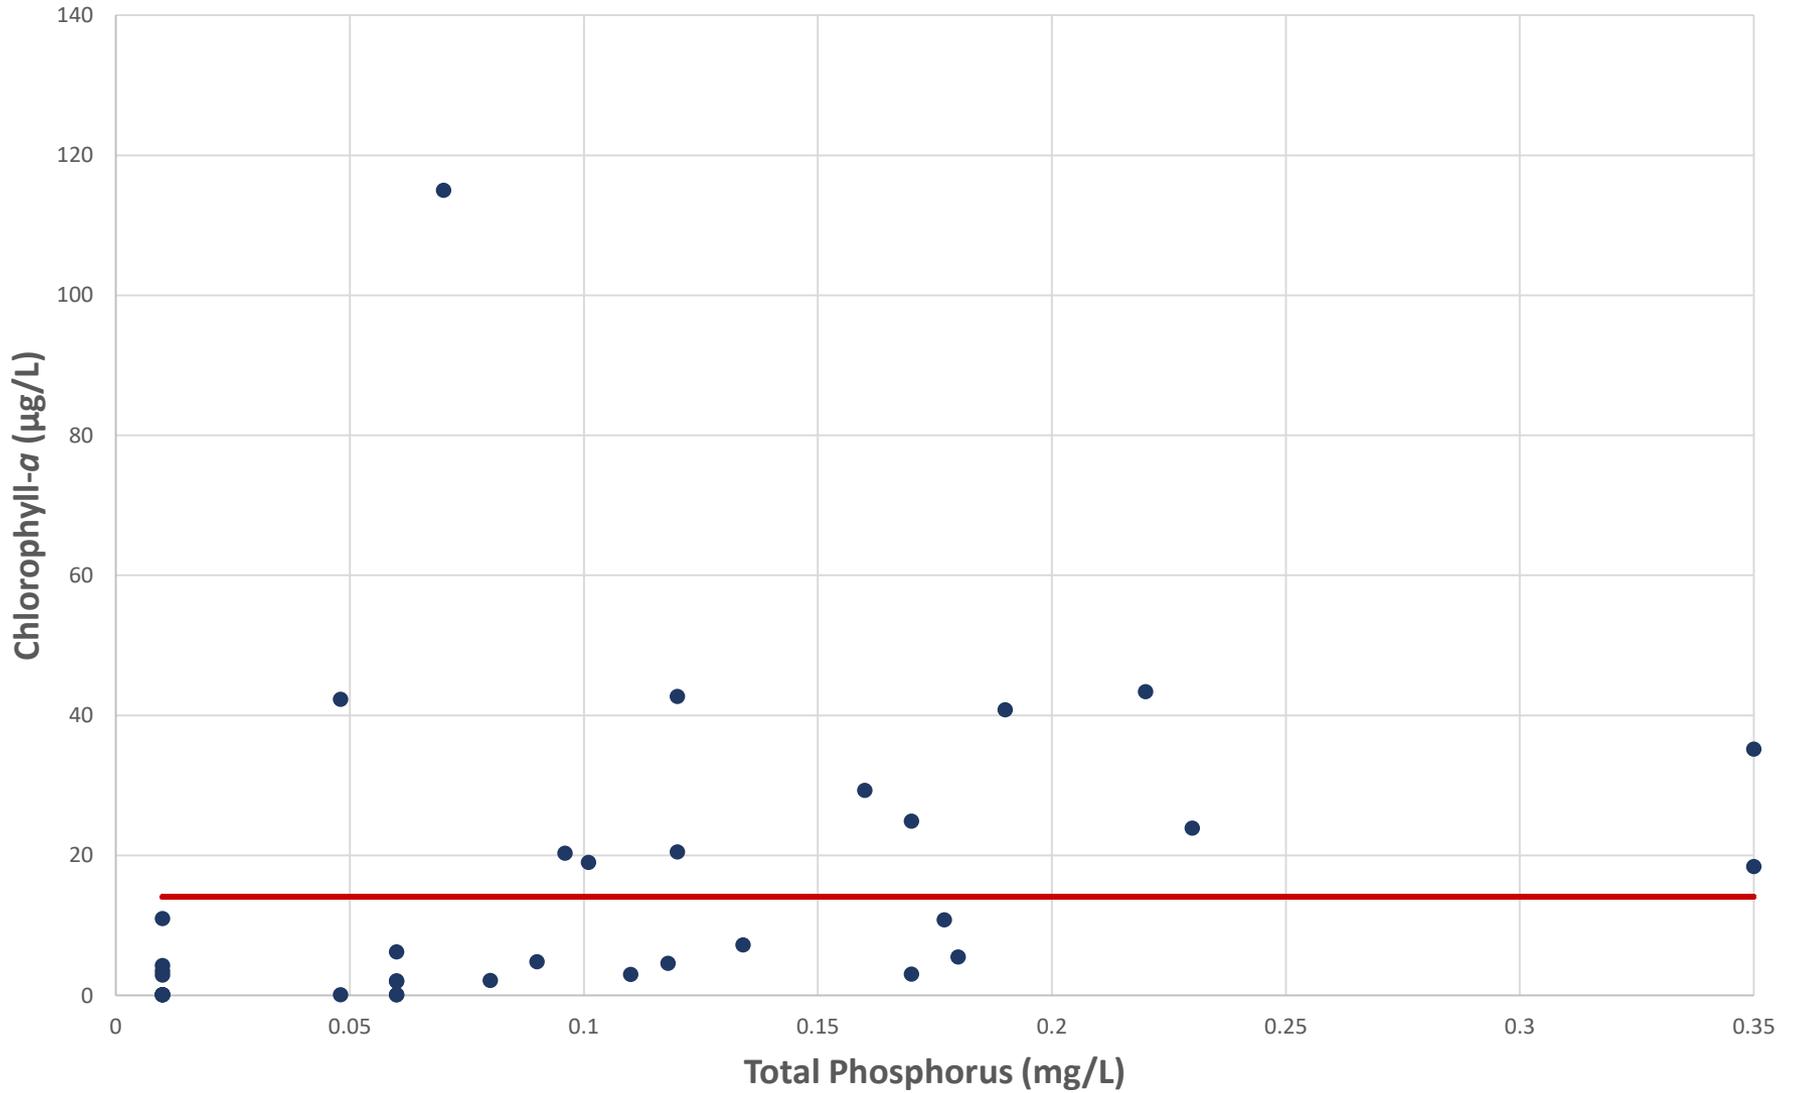
AU 0103C_01 Chlorophyll-*a* versus Total Phosphorus

- Lake Meredith (0102)
- Big Blue Creek (0102A)
- Canadian River Above Lake Meredith (0103)
- East Amarillo Creek (0103A)
- Unnamed Tributary to West Amarillo Creek (0103C)
 - No impairments
 - Chlorophyll-*a* concern

● Chlorophyll-a (ug/L) — Chlorophyll-a Screening Level

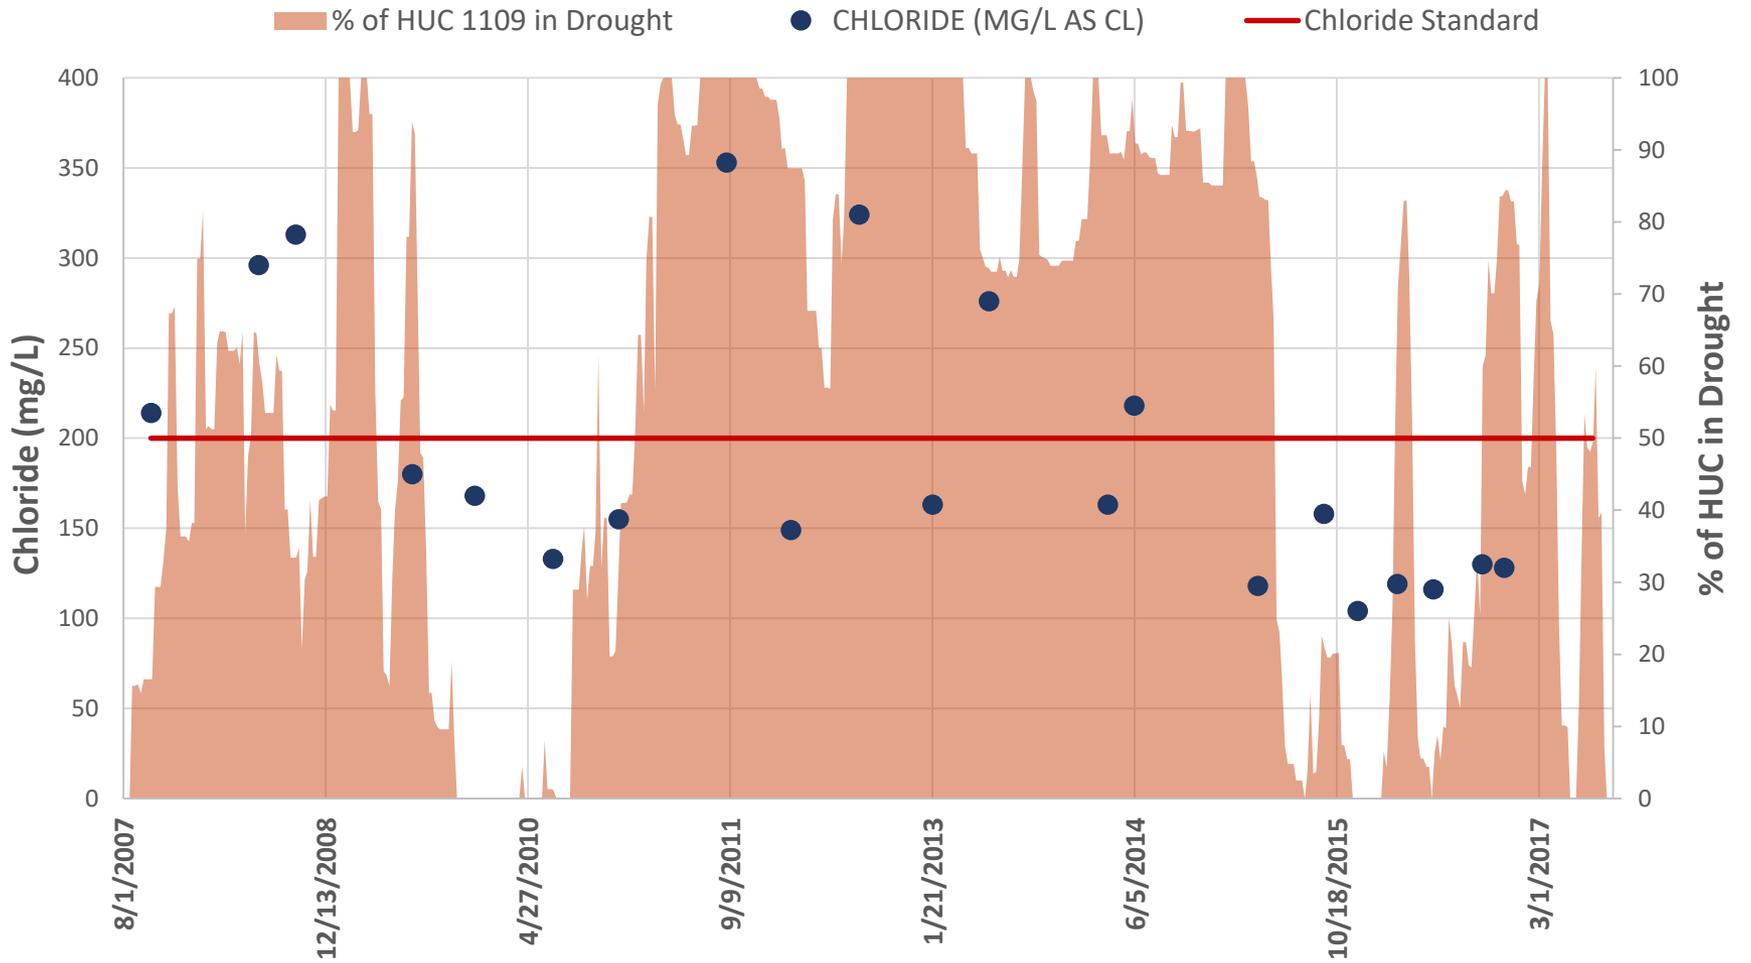
Segment 0105 Chloride

- Rita Blanca Lake (0105)
 - pH and chloride impairment
 - Ammonia, chlorophyll-*a*, nitrate, total phosphorus concerns

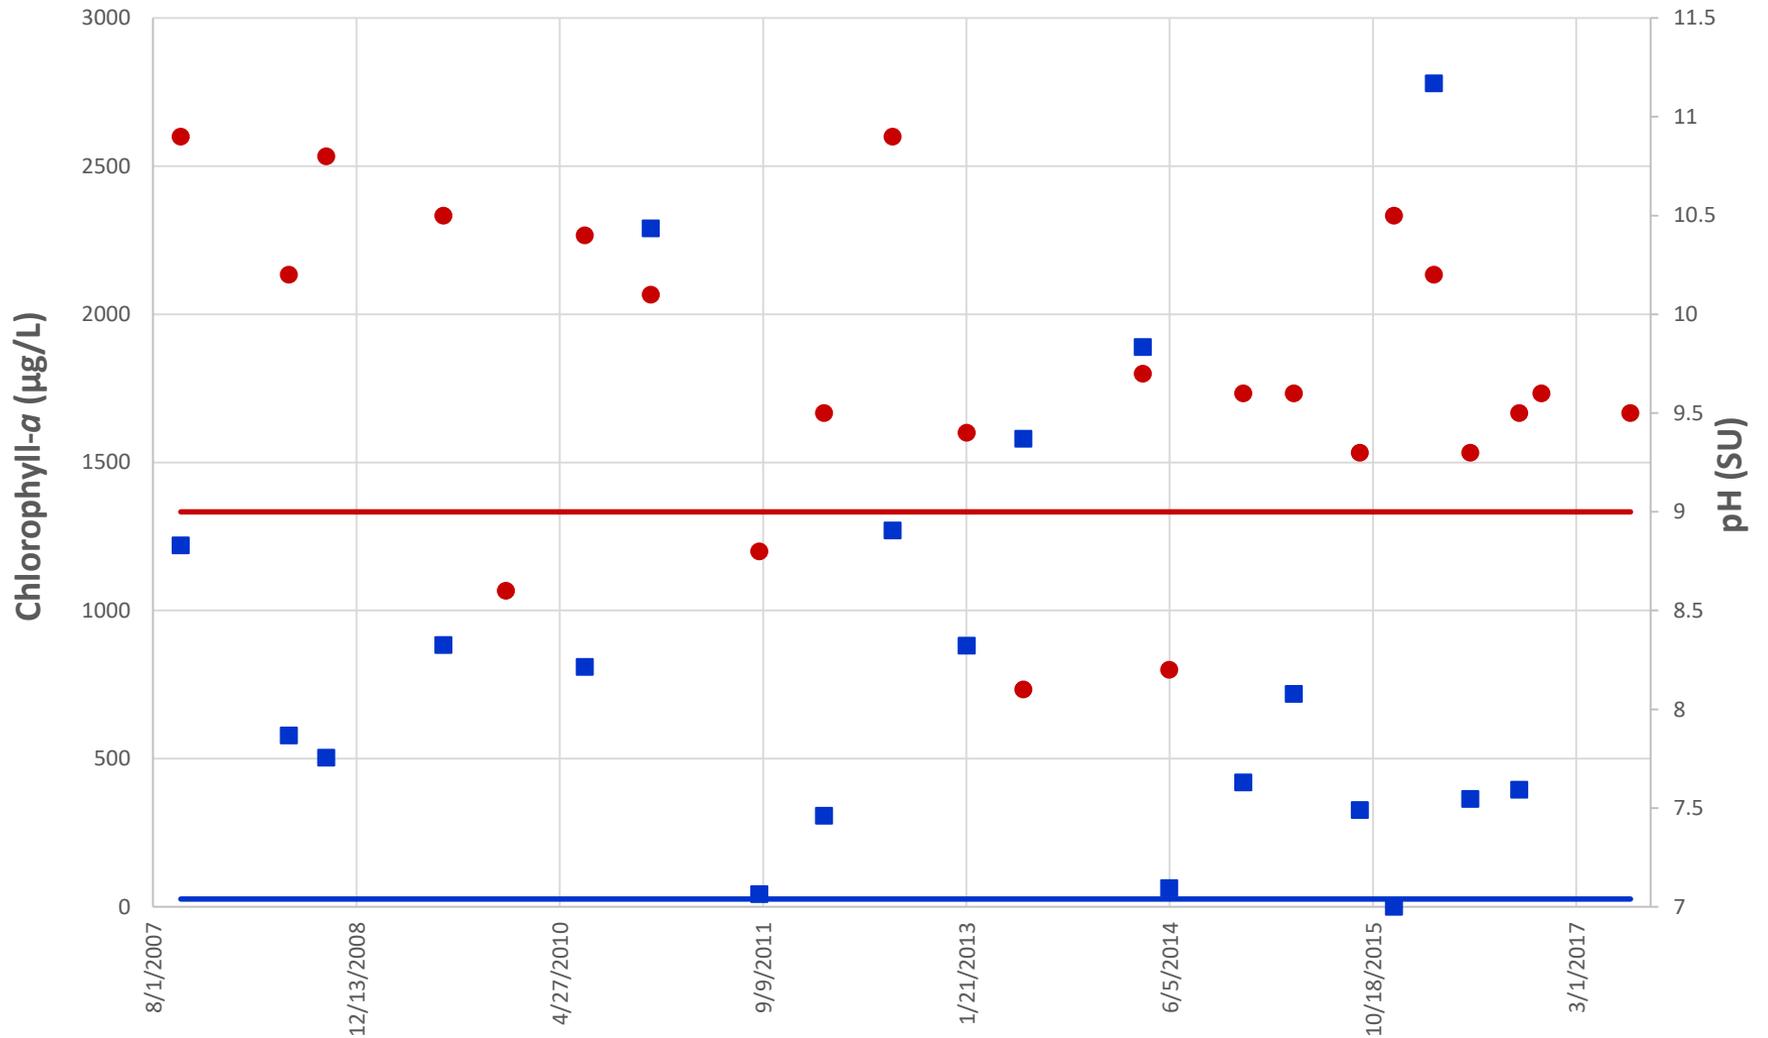
Segment 0105_01 Chlorophyll-*a* and pH

■ Chlorophyll-*a* (µg/L) — Chlorophyll-*a* Screening Level ● pH (SU) — High pH Standard

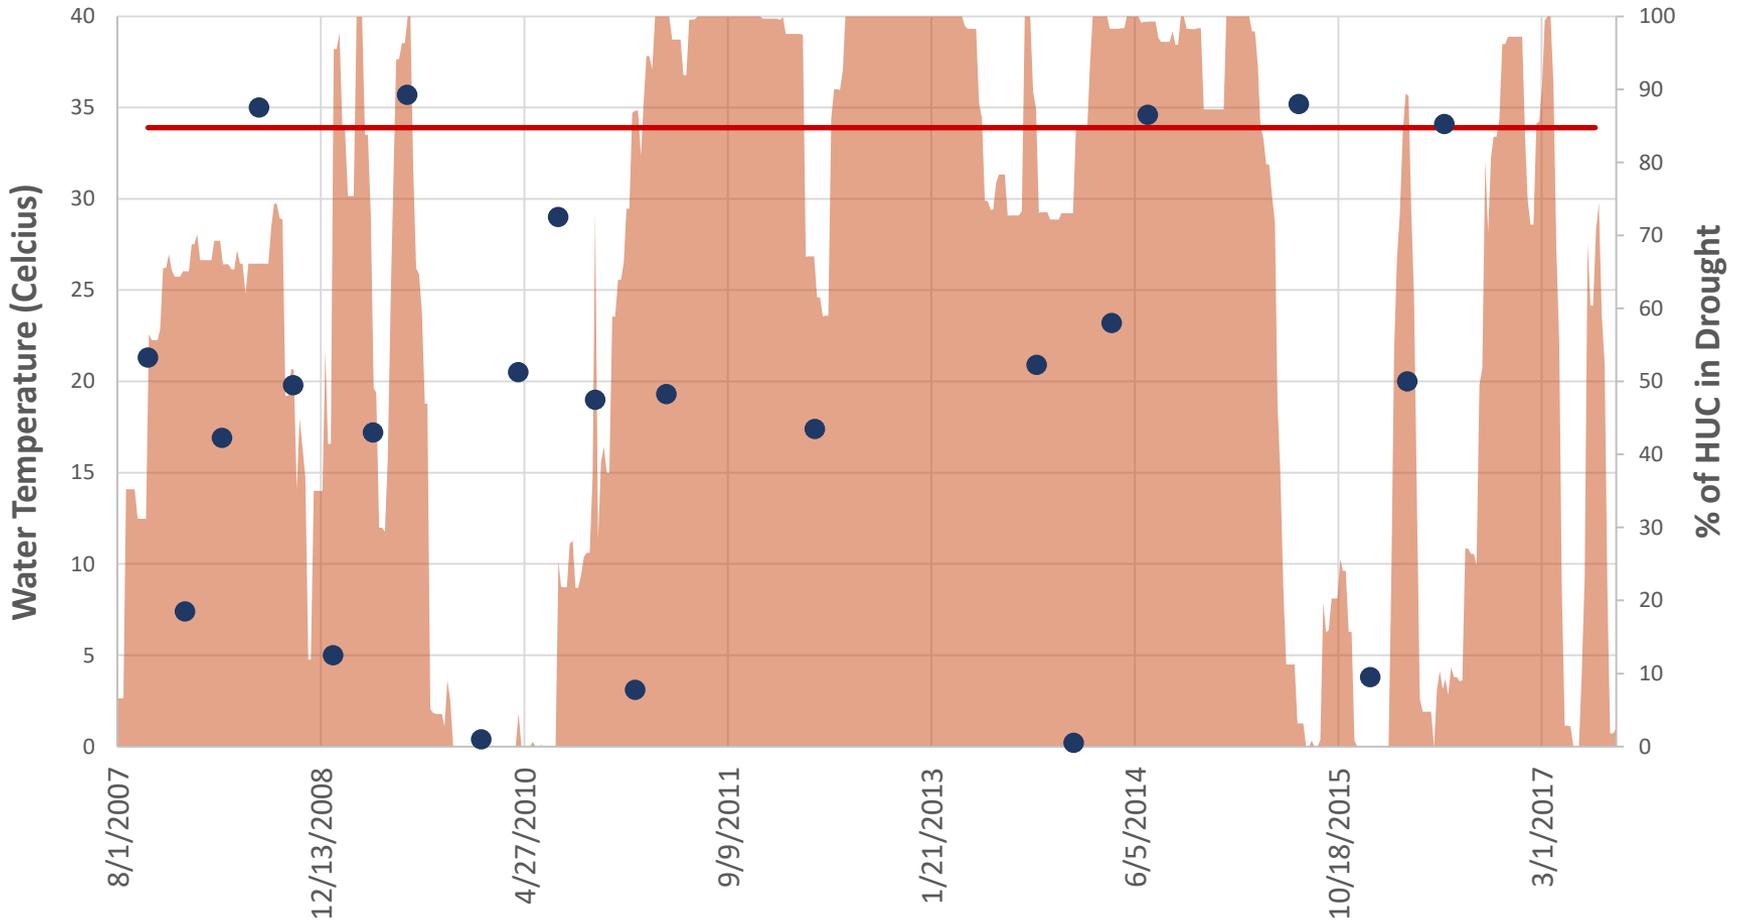
AU 0104_01 Water Temperature

- Wolf Creek (0104)
 - No impairments
 - Chlorophyll-*a* and Temperature concern
- Kiowa Creek (0199B)

■ % of HUC 1110 in Drought ● TEMPERATURE, WATER (DEGREES CENTIGRADE) — Water Temperature Standard
